Property Inspection Report

March 14, 2026 (8:00 AM)

112 Sample Street Sampleton, NC

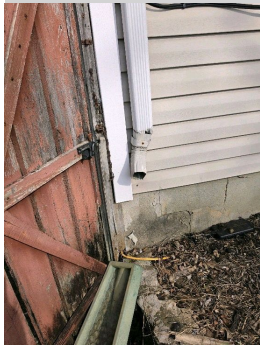
(C2-1.2) Main House

The gutter downspouts are not extended or piped to direct roof drainage away from the foundation in several locations. Direct drainage to the foundation and cladding from the gutter system can result in water penetration into the foundation area and foundation deterioration. A licensed general contractor should be consulted for a complete evaluation and to make necessary repairs.

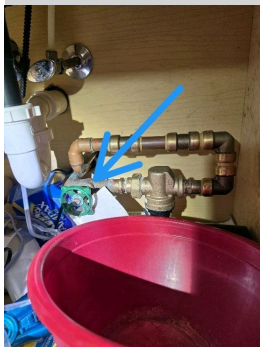
D1-1 Main (Location: bathroom 1)

For Your Records this is a photograph of the main water turn off.

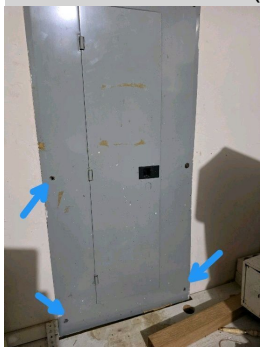
E2-1 Main Panel (Garage) (Location: Garage)

The main electrical service panel cover is missing fasteners that secure the cover to the enclosure. The door/cover prevents direct contact with hot electrical circuits and contains the electrical energy of the electrical system in the event of a short or electrical explosion; therefore the cover must be secured with the correct type, size and number of fasteners. This condition presents a safety hazard that could result in serious personal injury or death. A licensed electrical contractor should be consulted for a complete inspection of the electrical system and for repair/replacement of the panel to ensure that it is safe and functioning properly.

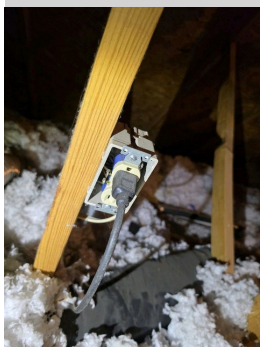
E4-1 Attic

Electrical connections have been made in the attic area without being properly protected in a covered junction box. The open junction leaves electrical conductors exposed and in a hazardous condition. Electrical concerns should be considered fire and safety issues and repaired as soon as possible. The electrical systems and components in the attic are in need of a complete evaluation and repair by a licensed electrical contractor.

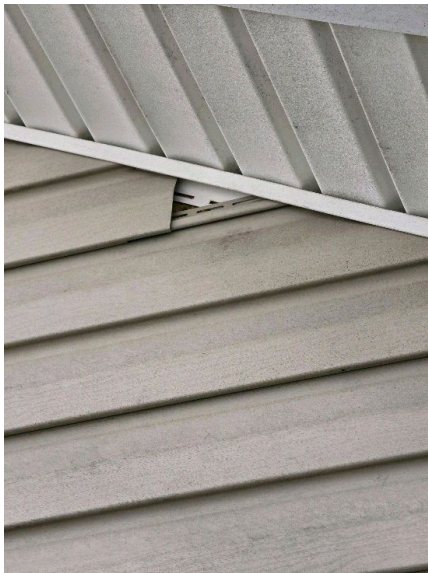
(A1-1.1) Main House

The exterior siding of the home is in need of further evaluation and repair, the following items were noted at the time of the inspection. A complete evaluation is needed as a repair plan is developed to determine the extent of the damage.

1. Missing siding
2. Damaged pieces
3. Warped siding

All systems listed should be evaluated and repaired as needed by a licensed general contractor to ensure that all systems are functioning as intended. The contractor should consult specialist in each trade as needed.

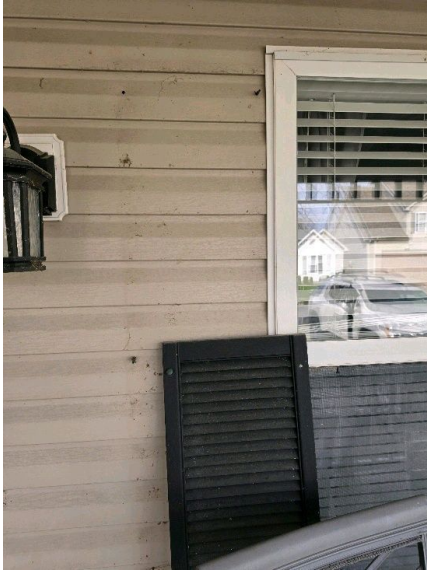
**(A1-1.2) Main House**

A shutter piece on the front porch is not attached. It was not determined if the piece can be reached without further work. A licensed general contractor should be hired to reattach the shutter.

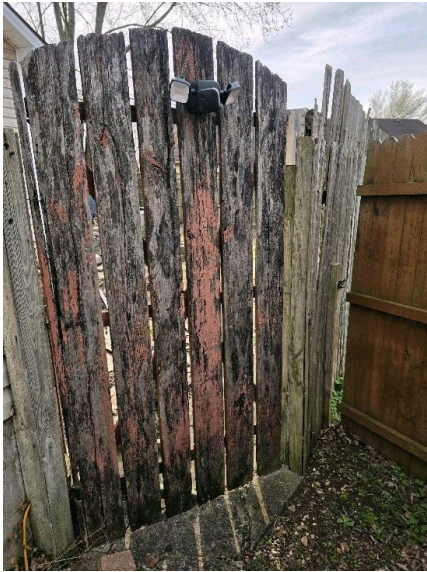
(A3-1.1) Porch

The fence around the home is in poor condition and needs to be replaced. A licensed general contractor should be hired to replace the fence

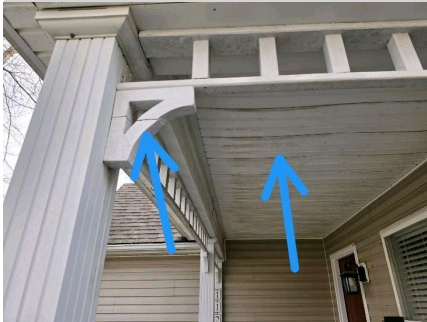
(A3-1.2) Porch

The porch is in need of further evaluation and repair, the following items were noted at the time of the inspection. A complete evaluation is needed as a repair plan is developed to determine the extent of the damage.

1. Damaged trim
2. Bowing soffit

A licensed general contractor should be consulted for further evaluation, to determine the extent of the damage, and to make necessary repairs.

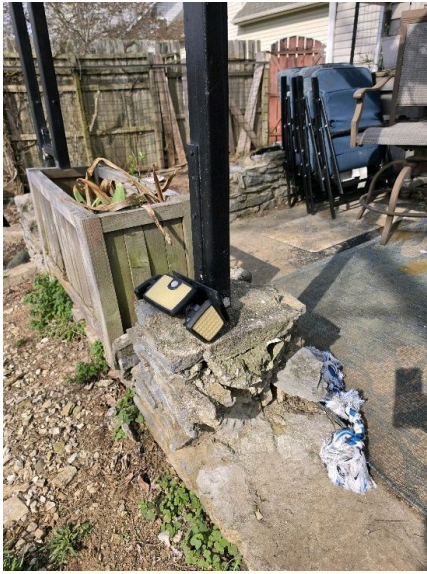
(A3-2.1) Porch

The porch is in need of further evaluation and repair, the following items were noted at the time of the inspection. A complete evaluation is needed as a repair plan is developed to determine the extent of the damage.

1. Damaged to columns
2. Eroded footings

A licensed general contractor should be consulted for further evaluation, to determine the extent of the damage, and to make necessary repairs.

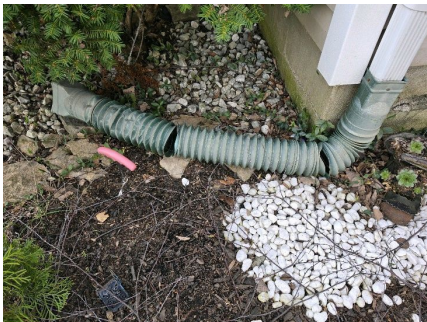
Corrections are needed to control drainage and to protect the foundation and living areas of the home. A licensed general contractor should be consulted for a complete evaluation and to make necessary repairs.

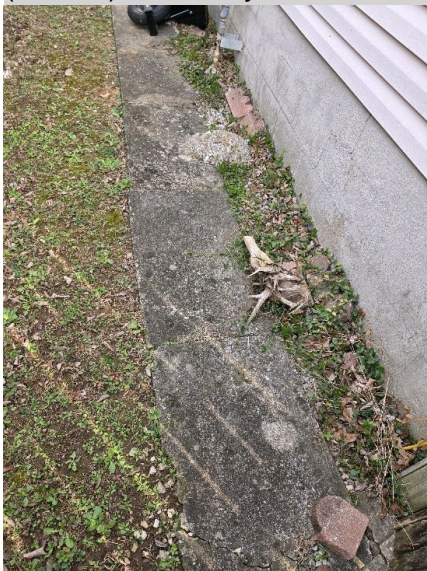
(A4-1.2) Driveway and Front Walk

The sidewalk has low areas along the walking surface that may hold water. This could result in trip hazards and icing during the winter months. A licensed general contractor should be consulted for further evaluation and repair.

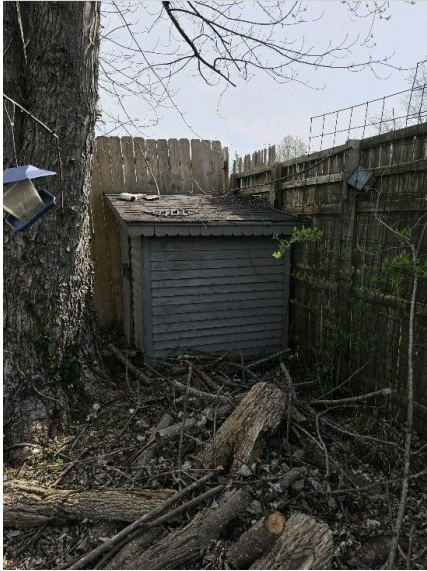
(A4-1.3) Driveway and Front Walk

Additional Photograph: This is a photograph of the outbuilding. The outbuilding was not inspected.

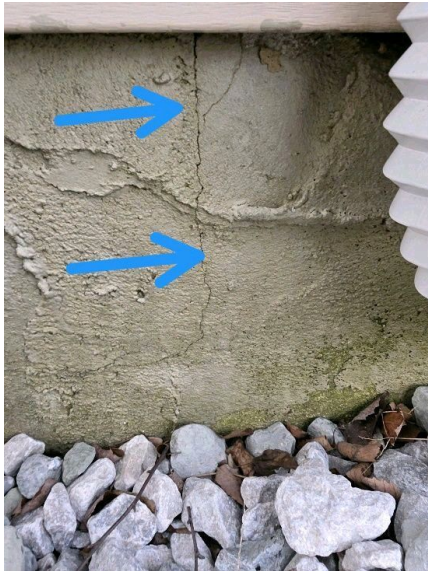
(B1-1.1) Main House

The foundation is in need of evaluation and repair to ensure stability and prevent further damage, the following concerns were noted at the time of the inspection:

1. Multiple hairline cracks
2. Stepping cracks
3. Damage at front of porch

All systems listed should be evaluated and repaired as needed by a general contractor to ensure that all systems are functioning as intended. If the repairs are beyond the scope of the building code the contractor should consult an engineer for a repair plan.

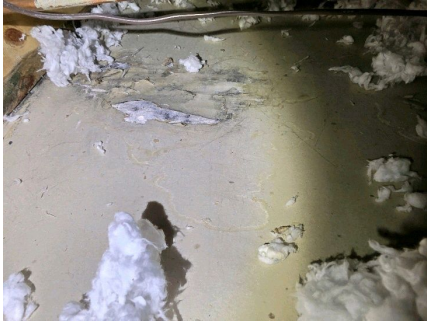
(B5-1.1) All Accessible Attic Areas

In the attic where the insulation is displaced there is evidence of a past leak, likely from the ac lines. The seller should be asked for a history of the leak and the steps taken to repair.

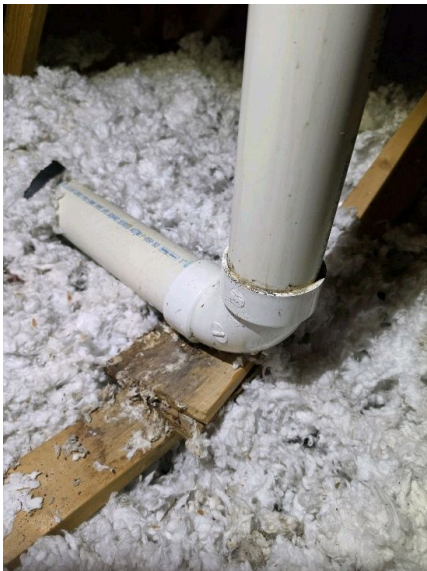
(B6-1.1) Main House

From the attic, the wood framing components located under the main plumbing vent are discolored and decayed. The level of decay indicates a long term leak that could involve hidden areas of damage, the flashing, and the roof covering systems. The area was also wet at the time of the inspection indicating an active leak. A licensed general contractor should be consulted for further evaluation and repair to determine the source of the leak and extent of the damage to ensure the stability of the home and prevent additional damage.

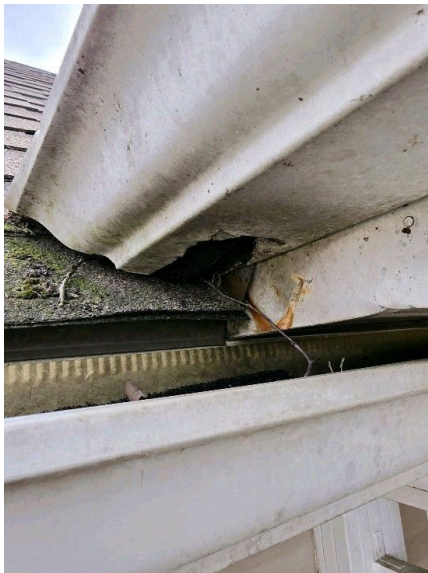
(C2-1.1) Main House

The roof gutters are in need of further evaluation and repair to reduce overflow to the foundation and cladding areas of the home. The following concerns were noted at the time of the inspection:

1. Poor installation: hole knocked into gutter for a drain
2. Moss on shingle from improper gutter clearance

It is very important to keep gutter functioning properly to reduce direct drainage to the foundation and wall cladding systems. A licensed general contractor should be consulted for a complete inspection to determine the significance of the concern and to make necessary repairs.

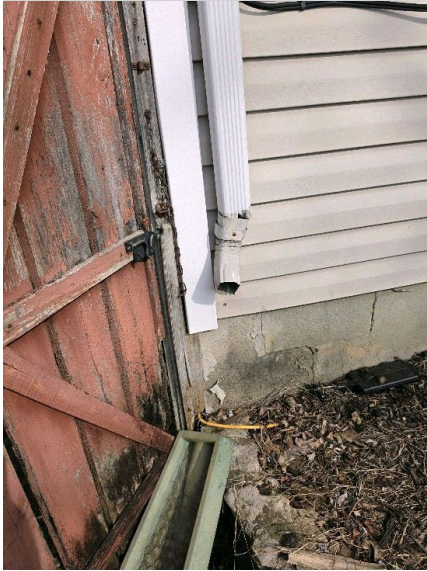
(C2-1.2) Main House

The gutter downspouts are not extended or piped to direct roof drainage away from the foundation in several locations. Direct drainage to the foundation and cladding from the gutter system can result in water penetration into the foundation area and foundation deterioration. A licensed general contractor should be consulted for a complete evaluation and to make necessary repairs.

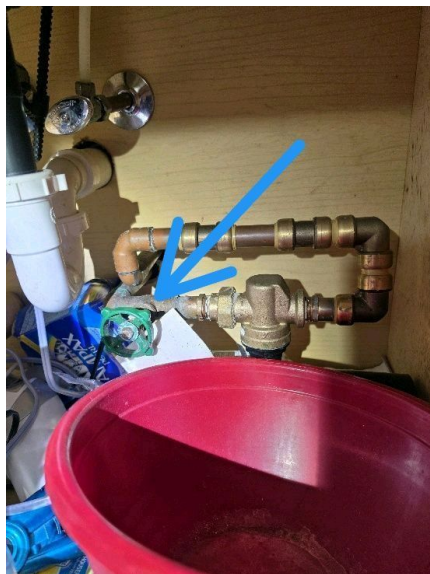
(D1-1.1) Main

For Your Records this is a photograph of the main water turn off.

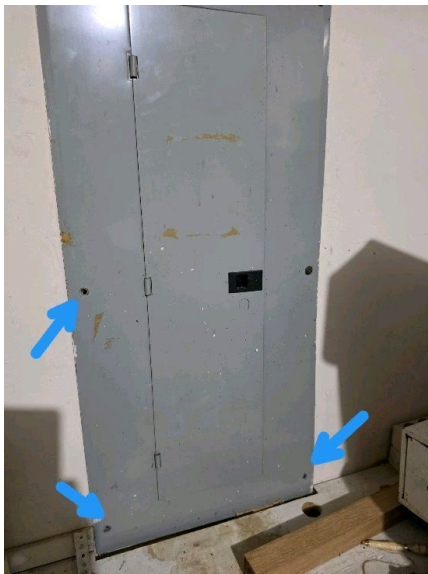
(E2-1.1) Main Panel (Garage)

The main electrical service panel cover is missing fasteners that secure the cover to the enclosure. The door/cover prevents direct contact with hot electrical circuits and contains the electrical energy of the electrical system in the event of a short or electrical explosion; therefore the cover must be secured with the correct type, size and number of fasteners. This condition presents a safety hazard that could result in serious personal injury or death. A licensed electrical contractor should be consulted for a complete inspection of the electrical system and for repair/replacement of the panel to ensure that it is safe and functioning properly.

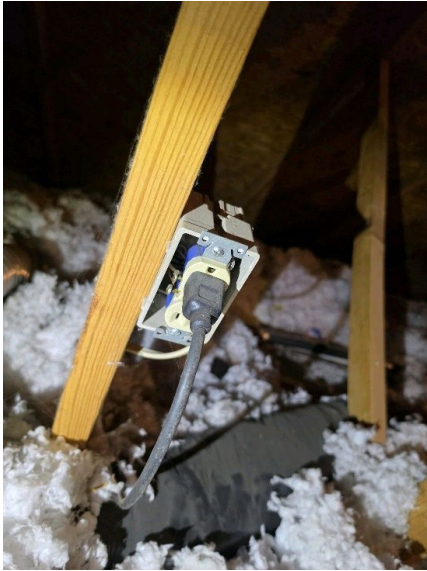
(E4-1.1) Attic

Electrical connections have been made in the attic area without being properly protected in a covered junction box. The open junction leaves electrical conductors exposed and in a hazardous condition. Electrical concerns should be considered fire and safety issues and repaired as soon as possible. The electrical systems and components in the attic are in need of a complete evaluation and repair by a licensed electrical contractor.

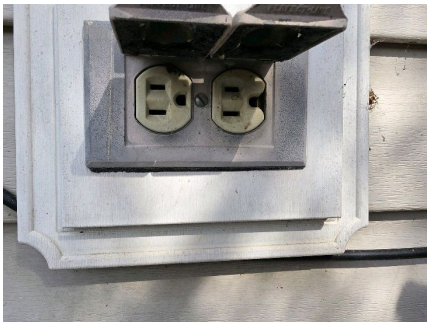
(E5-1.1) Porch

The receptacle(s) has/have cracked face. A cracked receptacle could result in increased shock and fire hazards. A licensed electrical contractor should be consulted to make necessary repairs to ensure safe and proper operation and installation.

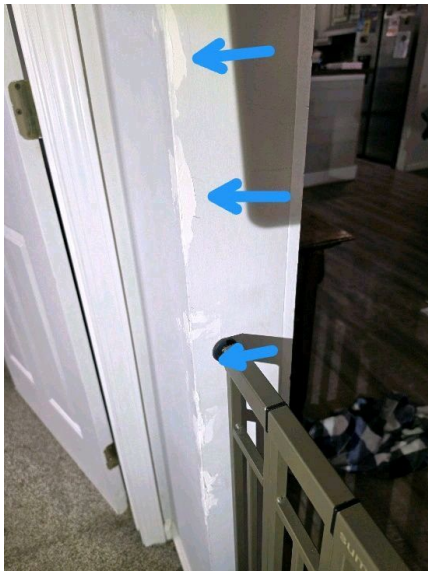
(H1-1.1) All Rooms

There are several instances inside the house if suspected pet damage. A licensed general contractor should be consulted for evaluation and repair.

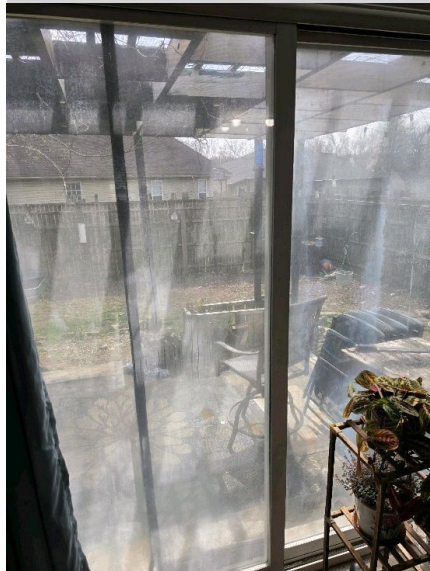
(H1-1.2) All Rooms

The sliding glass door in the dining area does not open smoothly and the glass is cloudy. This could be a safety hazard if the door sticks in an emergency. A licensed general contractor should be consulted for a complete evaluation and to make necessary repairs.

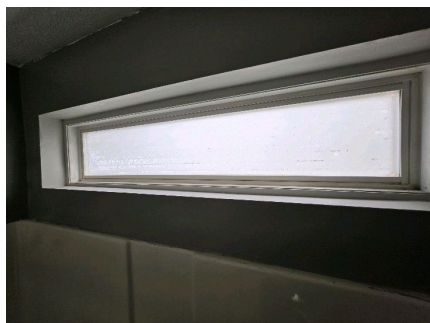
(H3-2.1) Bathroom 1

A window is present in the shower/tub area. The window is being exposed to constant water contact and could allow water penetration into the wall or framing areas. The window glass also presents a safety issue related to breakage and personal injury in the event that a person should slip or fall and impact the window. A licensed general contractor should be consulted to review the window and adjacent framing components for concerns related to water penetration, possible hidden damage, and safety concerns related to the glass in the shower area.

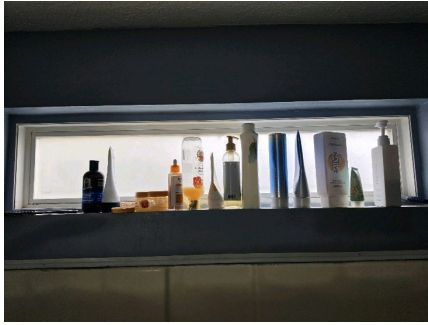
(H3-3.1) Bathroom: Primary

A window is present in the shower/tub area. The window is being exposed to constant water contact and could allow water penetration into the wall or framing areas. The window glass also presents a safety issue related to breakage and personal injury in the event that a person should slip or fall and impact the window. A licensed general contractor should be consulted to review the window and adjacent framing components for concerns related to water penetration, possible hidden damage, and safety concerns related to the glass in the shower area.

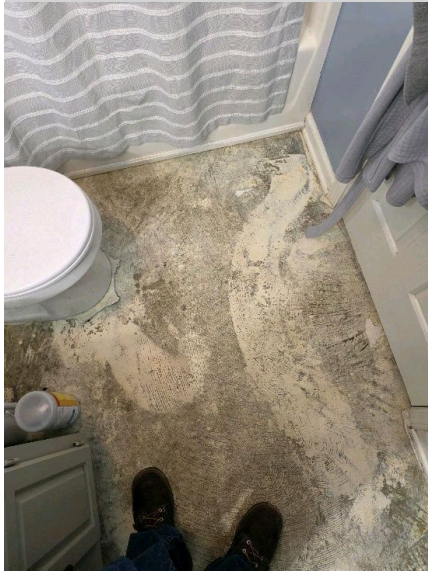
(H3-3.2) Bathroom: Primary

The floor in the primary bathroom is unfinished. A licensed general contractor should be consulted for installation.

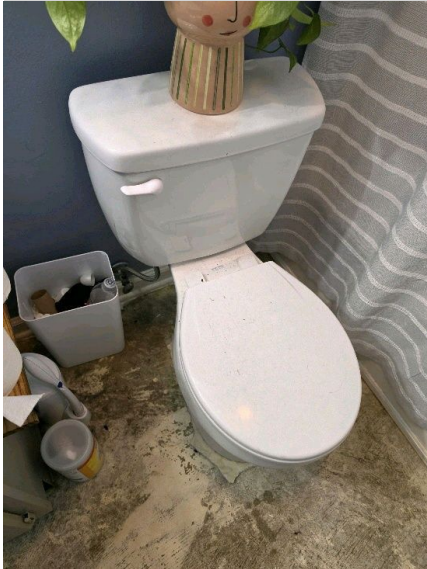
(H3-3.3) Bathroom: Primary

The primary toilet was noticed to be running continuously. A licensed plumber should be consulted for evaluation and repair.

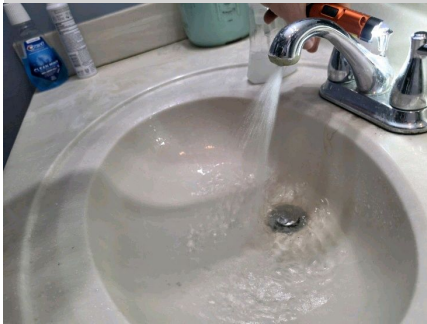
(H3-3.4) Bathroom: Primary

The aerator for the sink faucet was missing/ damaged. The aerator mixes air with the water volume to conserve water while providing a nice working pressure without splashing. A general repair specialist should be consulted to determine if replacement of the aerator is possible. A licensed plumbing contractor may be needed to replace the fixture if this is of concern and repair parts are not available.

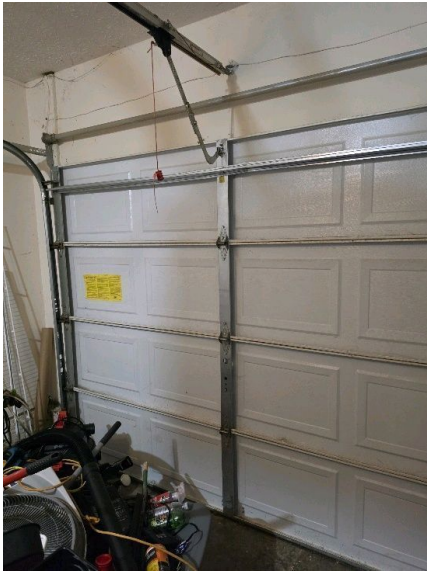
(H4-1.1) Garage

The garage door needs adjustment and repair. The door did not stop/reverse when the path was interrupted. A garage door installation company or a licensed general contractor should be consulted for evaluation and repair to ensure that the door operates safely and properly.

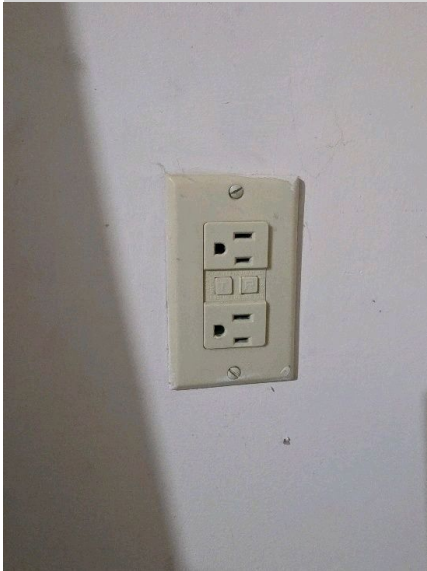
(H4-1.2) Garage

Additional Photograph: This is a photograph of the GFCI outlet in the garage. This outlet is in circuit with the exterior outlets. If the outside outlets lose power, check this GFCI.

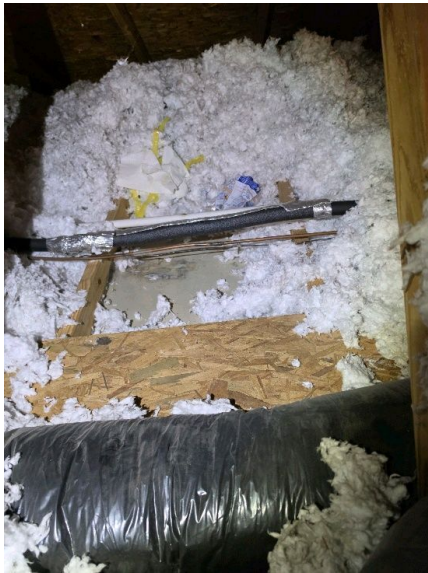
(I1-1.1) Attic: All Accessible

A section of insulation in the attic/crawl space is missing. Improper insulation installation could result in condensation, over heating of the building components, and inadequate conditioning of the living areas. A licensed general contractor should be consulted for repair/replacement.
